**Attachment M -
Richmond District Maintenance Yard**

**VDOT MS4 (General Permit No. VAR04)
Richmond District Complex Facility
VDOT District No. 4**

Site Visit Report Prepared by: Bobby Jacobsen (PG Environmental, LLC)

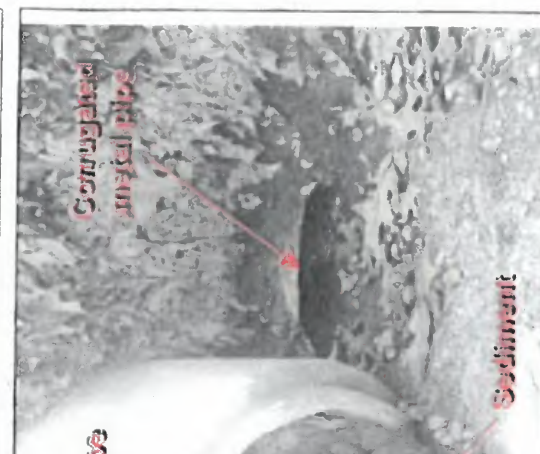
4. A storm drain drop inlet located along the fence line directly north of the equipment storage shed was surrounded by unstabilized sediment and did not have BMPs for inlet protection (see Photograph 1). VDOT staff explained that the drop inlet was connected to a corrugated metal pipe which discharged beyond the Facility fence line to the north. The corrugated metal pipe was almost completely full of sediment (see Photograph 2). In addition, there was a concrete pipe adjacent to the drop inlet to convey stormwater runoff beyond the Facility fence line to the north. Accumulated sediment was observed within the downgradient end of the pipe (see Photograph 2). The VDOT Consultants from EEE Consulting, Inc. explained that these pipes would be considered "points of discharge" from the Facility which convey flow to drainage channels that ultimately discharge to Timsbury Creek. They explained that in this case, the "regulated outfall" would be the location at which the conveyance channel downgradient of the outfall pipes discharged into an unnamed waterbody that flows into Timsbury Creek (see Photographs 3 and 4).

<p>Photograph 1 – View of storm drain inlet north of the equipment storage shed. Note unstabilized sediment surrounding the inlet.</p>

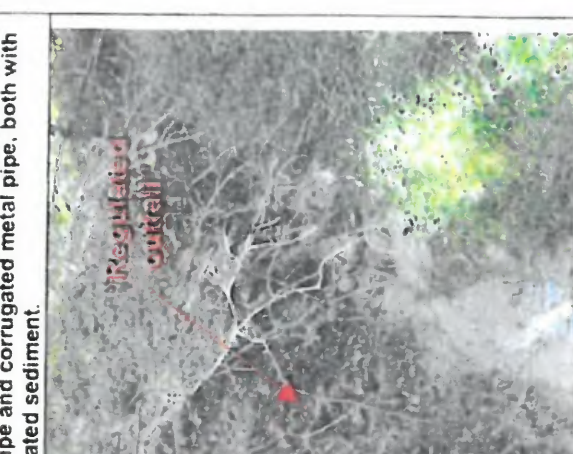
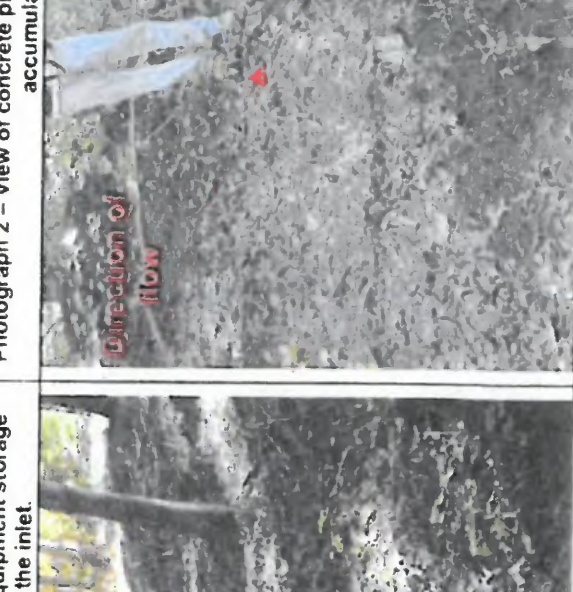
<p>Photograph 3 – View of conveyance downgradient of "point of discharge" shown in Photos 1 and 2.</p> <p>Photograph 4 – View of what EEE Consulting, Inc. considered the "regulated outfall" associated with the point of discharge in Photos 1 and 2.</p>

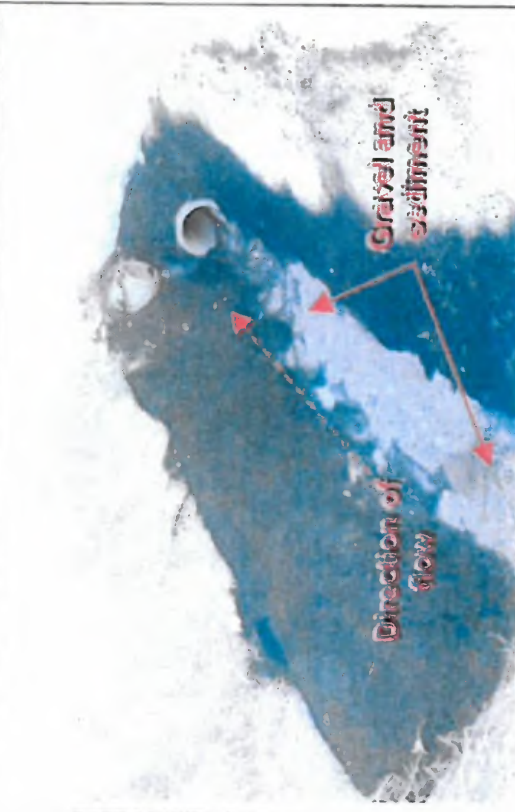
7. Sediment and gravel was observed in an asphalt-lined conveyance channel upgradient of a point of discharge from the facility along the northern fence line located to the northwest of the equipment storage shed in the northern portion of the site (see Photographs 9 and 10).

Photograph 9 – View of sediment and gravel in conveyance channel northwest of the equipment storage shed.

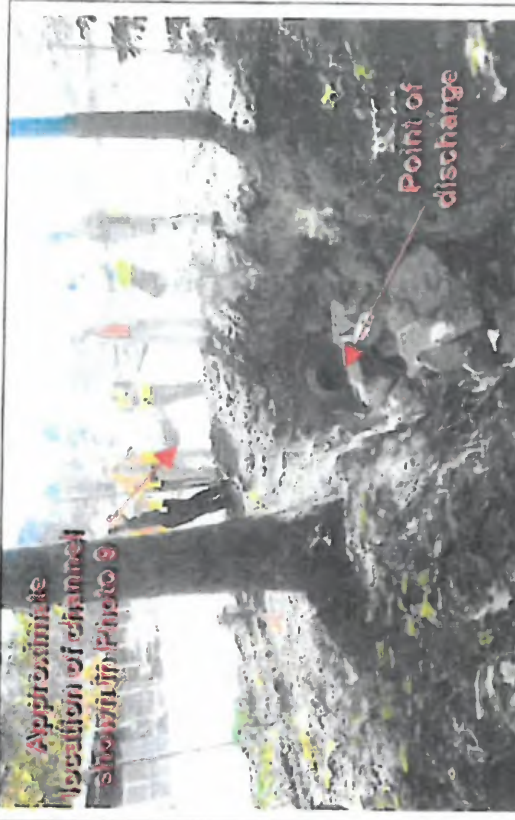
Photograph 10 – View of point of discharge location downgradient of conveyance channel shown in Photo 9.

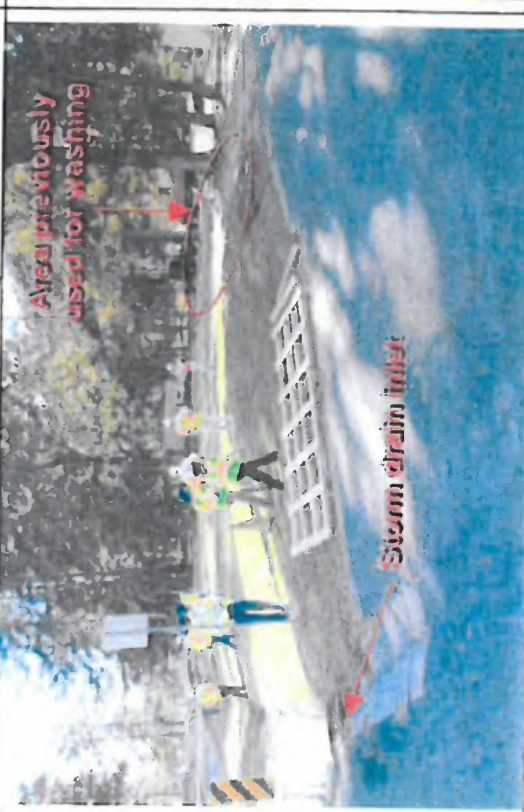
8. The VDOT Facility Manager explained that Facility staff previously conducted vehicle and equipment washing in two outdoor areas at the Facility--(one in the eastern portion and one in the western portion of the Facility, but about one month prior to the EPA inspection, they had been instructed not to wash vehicles or equipment outside. Both outdoor washing locations were within about 50 feet of the storm drain inlets (see Photographs 11 through 14). The VDOT Facility Manager explained that staff were instructed to wash vehicles and equipment in the indoor washing station or go to the Chester Area Headquarters Facility to conduct washing activities. He added that VDOT was working on plans to install an engineered outdoor wash pad at the Facility within a couple weeks of the site visit. VDOT staff explained that the Virginia Department of Environmental Quality (DEQ) had approved a wash pad design that allowed for wash water to be captured on site and infiltrate into the ground surface.

Photograph 11 – View of area previously used for vehicle and equipment washing in eastern portion of facility. Note proximity of storm drain inlet.

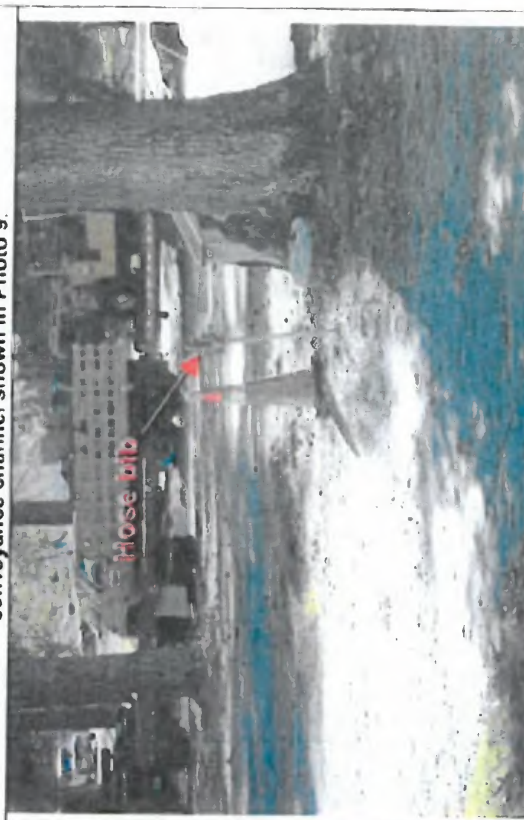
Photograph 12 – Closer view of area previously used for vehicle and equipment washing.

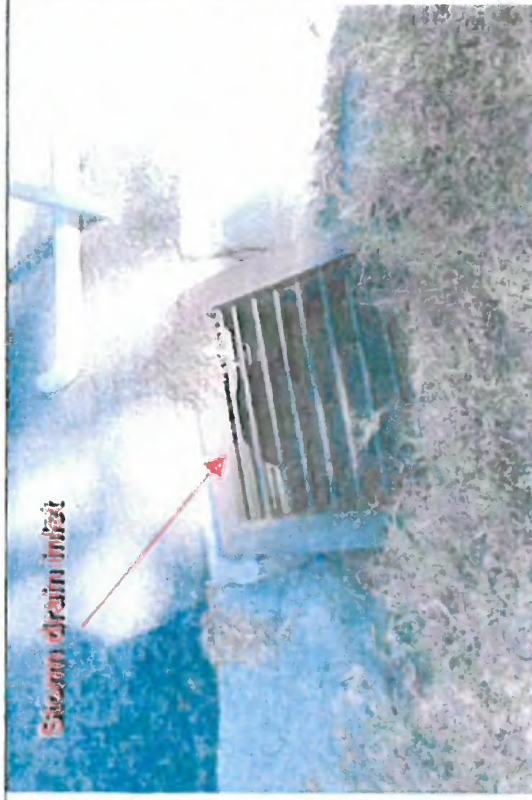
Photograph 13 – Closer view of storm drain inlet noted in Photo 11

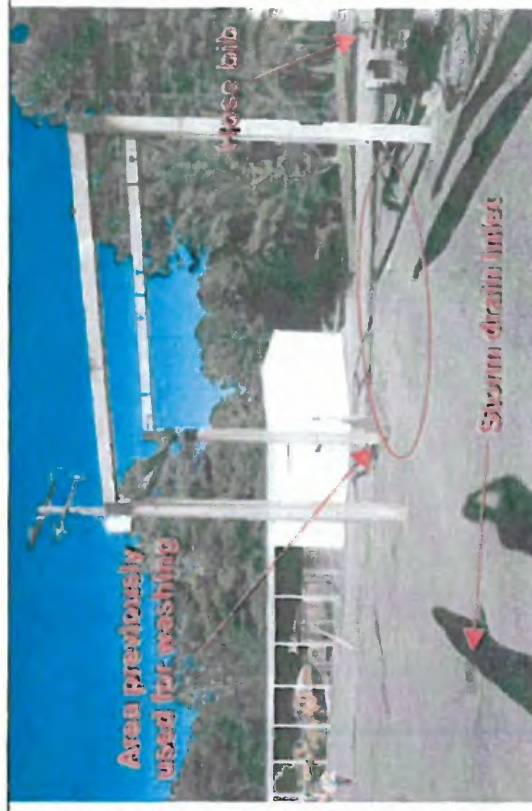
Photograph 14 – View of area previously used for vehicle and equipment washing in western portion of facility. Note proximity of storm drain inlet.

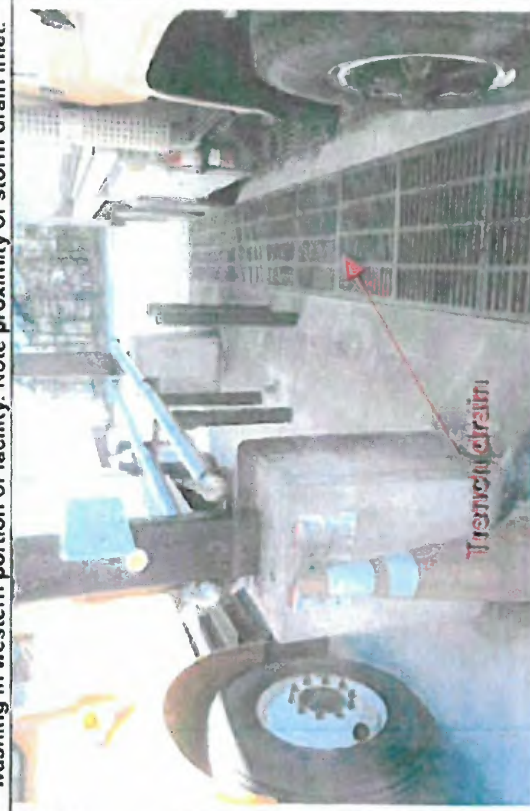
9. The VDOT Fleet Operations Manager explained that the Facility staff did not have a standard protocol or schedule for determining when the spill containment system in the bulk fueling area and bulk fuel unloading area should be maintained (i.e., solids cleaned out from system). He stated that the two staff members which work in the bulk fueling area conduct visual inspections and determine when the system should be maintained. He added that he believed the last time it was cleaned out was at the beginning of 2011. Trench drains were present in the bulk fueling area which connected to additional trench drains downgradient in the bulk fuel unloading area (see Photographs 15, 16, and 17). The VDOT Fleet Operations Manager explained that the trench drain containment system is equipped with a shutoff valve that is kept closed when fueling and fuel loading and unloading operations are taking place, and open at other times to allow stormwater runoff to be conveyed through the trench drain system outlet and off site (see Photographs 18, 19, and 20). The outlet would convey flow through two pipes near the fence line in the southeastern corner of the Facility (see Photographs 21 and 22). Timsbury Creek is located about 100 yards to the east of the fence line of the Facility in this location. It was unclear to the EPA Inspection Team whether EEE Consulting, Inc. had identified this location as a "point of discharge" from the facility. The VDOT Fleet Operations Manager explained that if stormwater were accumulated in the trench drain containment system, it would be tested with "fuel indicator paste" to determine the presence or absence of petroleum products in the water prior to discharge. The VDOT Fleet Operations Manager stated that if petroleum products were detected in the accumulated water, the Facility would have a local waste disposal company pump out the fluid and dispose of it, or the Facility would pump the fluid to 55-gallon drums which would then be picked up for disposal.

Photograph 16 – View of trench drain in bulk fueling area.

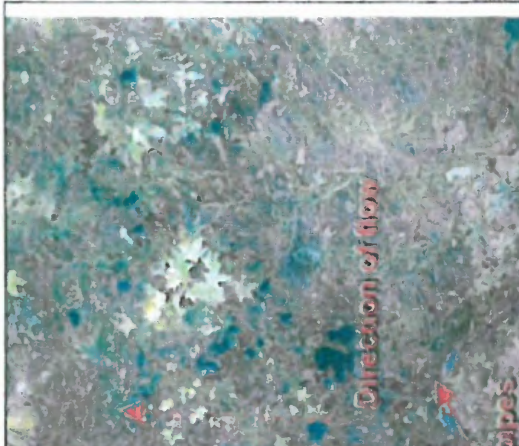
<p>Photograph 21 – View of outlet pipe from trench drain containment system and direction of flow through outlet pipes off site to the east.</p>

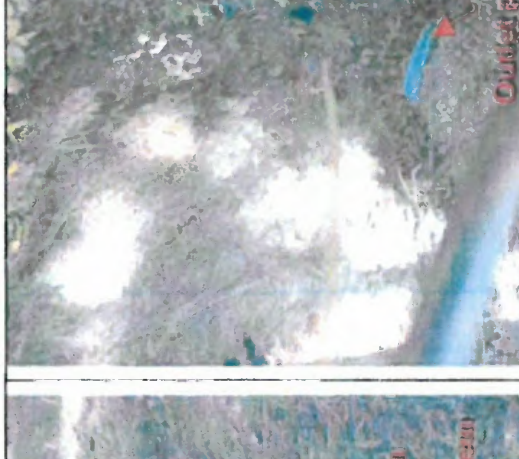
<p>Photograph 22 – View of downgradient end of outlet pipes shown in Photo 21 which would be a "point of discharge" from the Facility.</p>
